Manhole Inspection Summary

Manhole # S330__050MH

Insp Date: **4/24/09 9:53 AM**

Location Address: **825 sharp st**

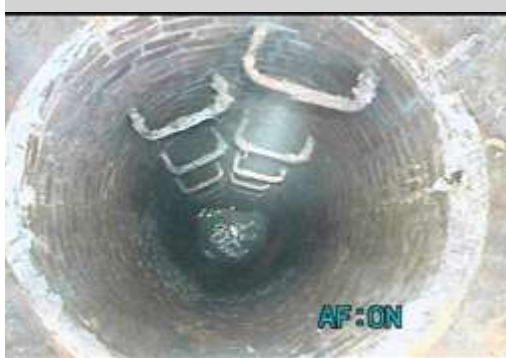
Defect 3

Steps Count: **24** Missing: **0** ☒ **Corroded**

corr steps

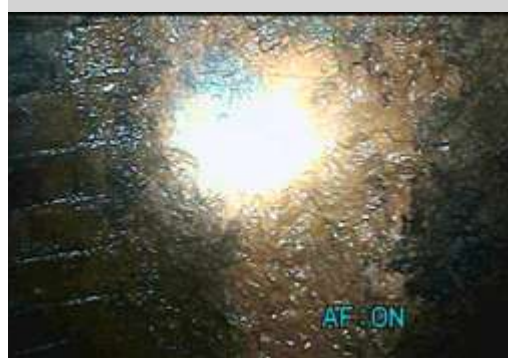
Defect 2

Infiltration: ☐ None ☐ Joint ☐ Cracks ☐ Mortar ☐ Roots ☒ **Wall**

corbal wall infiltration

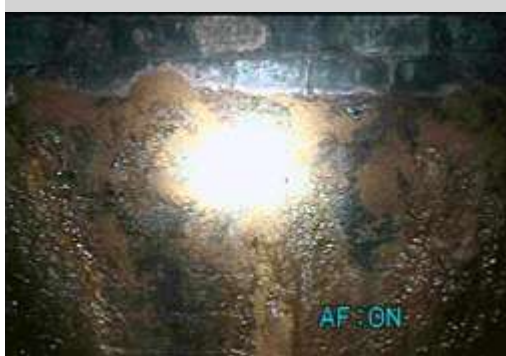
Defect 1

Infiltration: ☐ None ☐ Joint ☐ Cracks ☐ Mortar ☐ Roots ☒ **Wall**

barrel wall infiltration

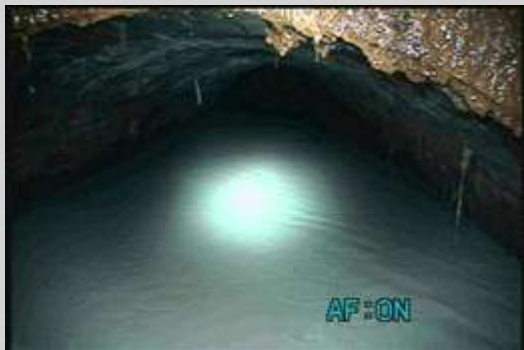
12 O'Clock Outflow

invert is 33.83

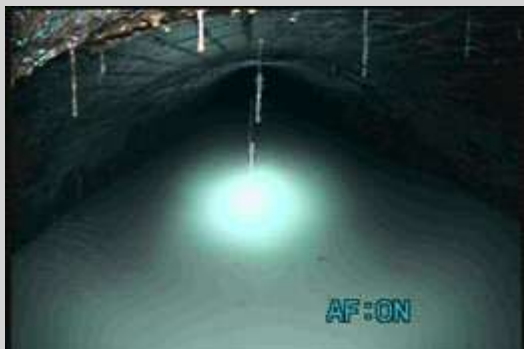
6 O'Clock Inflow

invert is 33.58
